**Flood Control Project Maintenance
Levee Inspections**

Maintenance Issue Types Only, Levee Inspection Report By Mile - Spring 2020

Levee District No. 0009 (Sutter County)

Waterway	Bank	Unit Miles	Inspection Start/End	Inspector
Unit No. 01 Sutter County, Feather River	Right	6.25	03/17/2020 03/17/2020	Sterling York

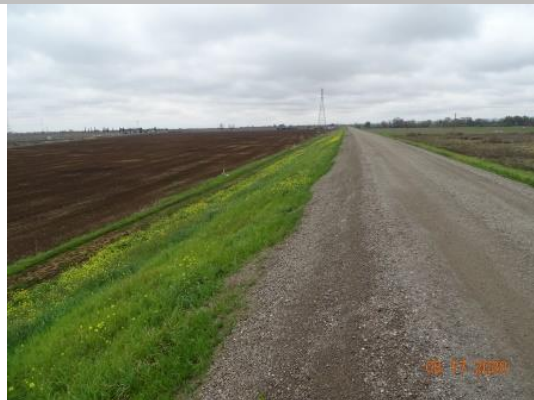
Photo 1 of 1 : SP_2020_LD0009_202_1_20200324_00004.jpg

LM Start	0.09	Rating **	A	Issue No.	1
LM End	6.24	Issue Type +	Ma	Location *	LS
Category	Earthen Levee			GPS Latitude/Longitude	
				Start	End
Item	Vegetation			39.170015 °	39.255723 °
				-121.622592 °	-121.636388 °
DWR ID	DWR_LD0009_01_s_2020_1				
Comment Code					
V1 : Control annual grass and weeds on the levee slopes and easements.					
Inspector Comment					
The annual vegetation is well maintained, Spring 2020.

View looking upstream landside of the well maintained annual vegetation, Spring 2020.

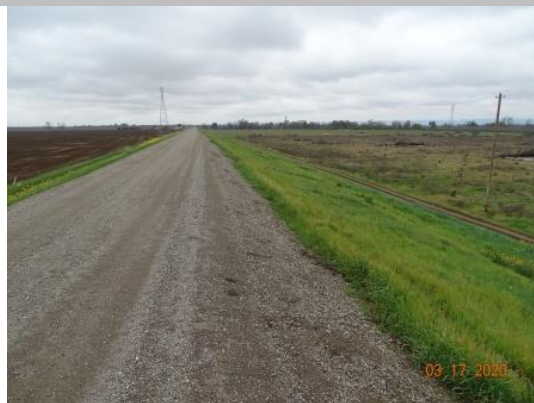
Photo 1 of 1 : SP_2020_LD0009_202_2_20200324_00003.jpg

LM Start	0.09	Rating **	A	Issue No.	2
LM End	6.24	Issue Type +	Ma	Location *	WS
Category	Earthen Levee			GPS Latitude/Longitude	
				Start	End
Item	Vegetation			39.170015 °	39.255723 °
				-121.622592 °	-121.636388 °
DWR ID	DWR_LD0009_01_s_2020_2				
Comment Code					
V1 : Control annual grass and weeds on the levee slopes and easements.					
Inspector Comment					
The annual vegetation is well maintained, Spring 2020.

View looking upstream waterside of the well maintained annual vegetation, Spring 2020.

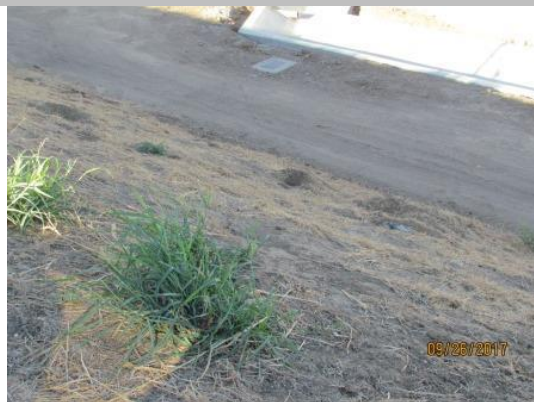
Photo 1 of 1 : SP_2020_LD0009_202_18_20200227_00001.jpg

LM Start	0.09	Rating **	M	Issue No.	18
LM End	0.09	Issue Type +	Ma	Location *	LS
Category	Earthen Levee			GPS Latitude/Longitude	
				Start	End
Item	Animal Control			39.170064 °	39.170064 °
				-121.622563 °	-121.622563 °
DWR ID	DWR_LD0009_01_f_2016_18				
Comment Code					
A3 : No rodents visible, but rodent burrows visible; need to backfill and compact or grout burrows.					
Inspector Comment					
No rodent activity was observed, holes need to be backfilled.

View on landside of rodent activity and holes.
